US Army Corps
of Engineers

TECHNICAL REPORT REMR-CS-4

REPAIR OF WATERSTOP FAILURES: CASE HISTORIES

James E. McDonald

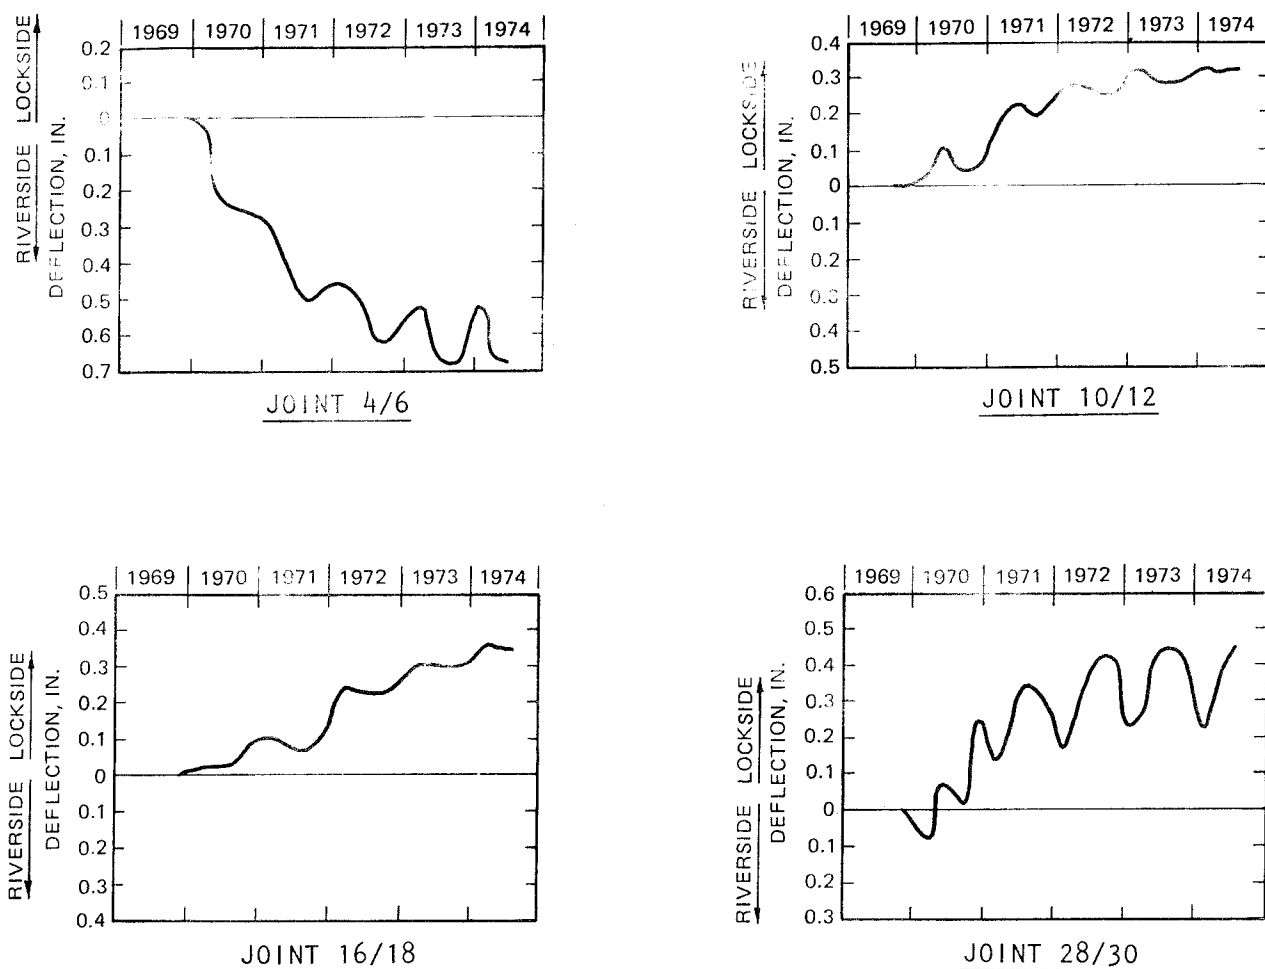
(Figure 62). Total failure of the waterstop at monolith joint 4/6 was reported as a result of the relative displacement between the adjacent monoliths. When the lock was filled, water leaked through the joint and spilled three deep into the parking area near monolith 6 (Figure 63). Most of the other monolith joints exhibited varying rates of leakage.

Figure 62. Maximum relative displacements of lock monoliths, Little Goose Lock

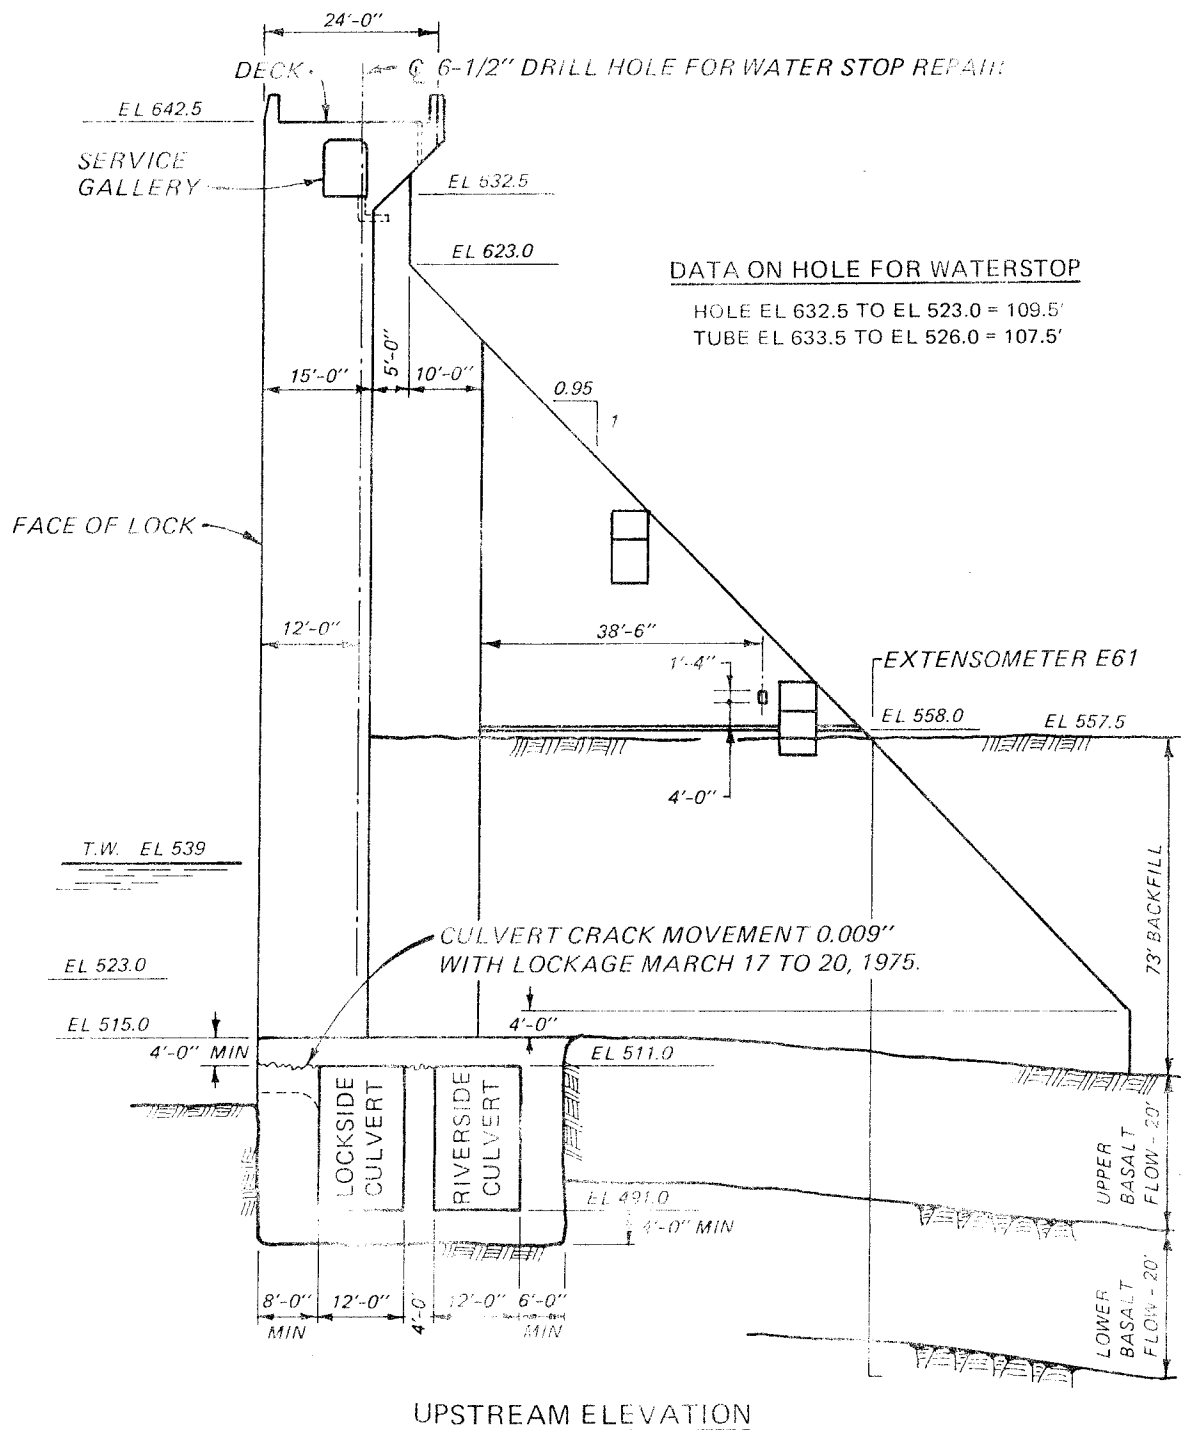
Figure 64. Location of trial waterstop repair, Little Goose Lock

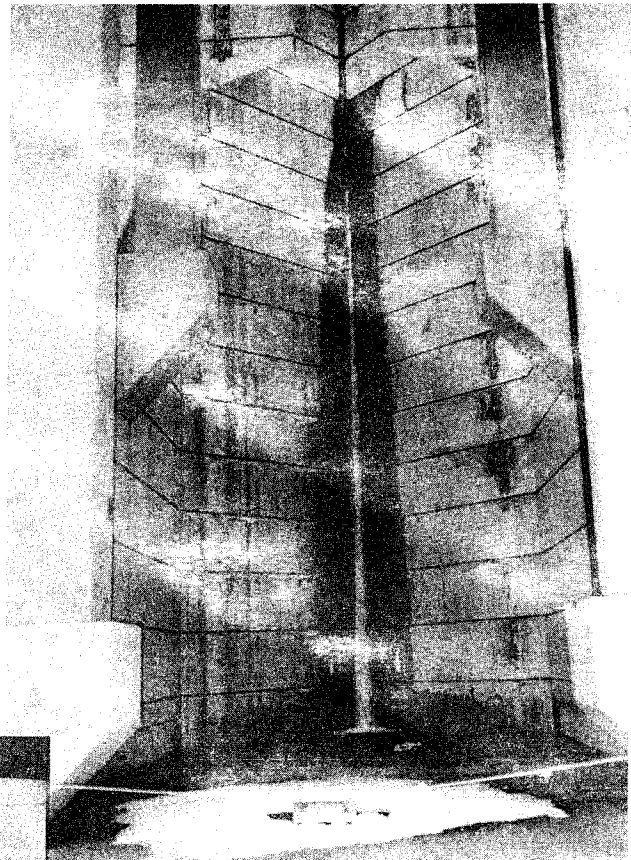
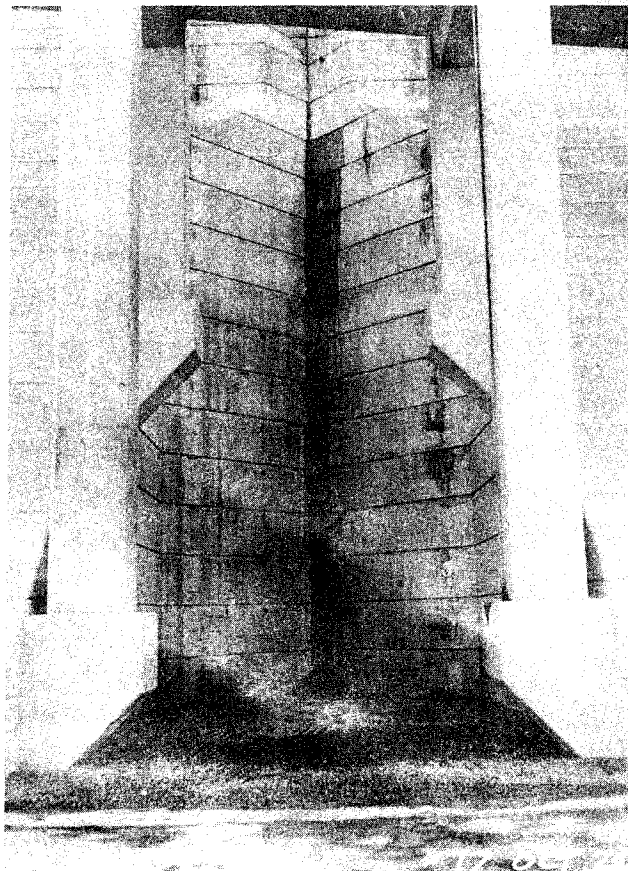
Figure 65. Monolith joint 10/12 leakage before and after repair, Little Goose Lock

152. Based on the Ice Harbor and Little Goose trial repairs, the drill hole with elastic filler method was selected to reestablish monolith joint waterstops at Little Goose Lock. Repairs were accomplished under contract in 1978 by drilling a 6-in.-diameter vertical hole along the joints from the deck to about 5 ft into bedrock and then filling the holes with AM-9 chemical grout to create a cast-in-place waterstop. This repair stopped an estimated 95 percent of the leakage. Leakage at selected joints before and after repair is shown in Figures 65 and 66.

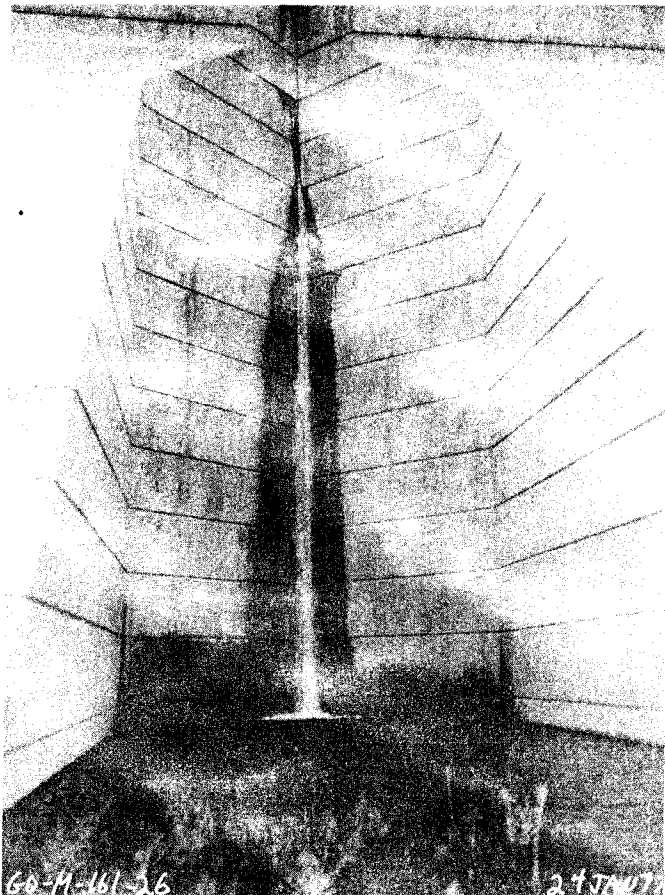
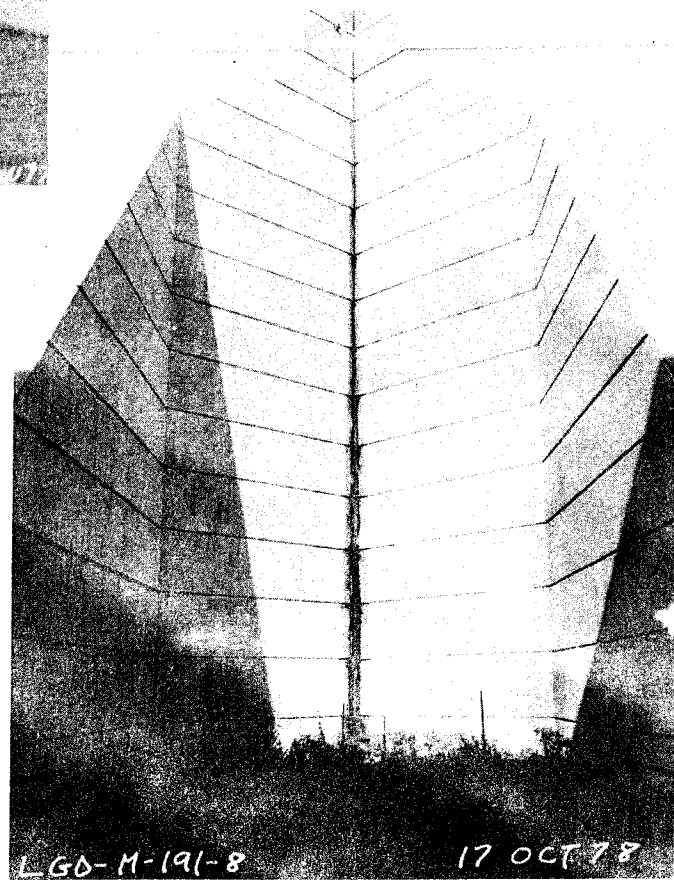
Figure 66. Monolith joint 11/13 leakage before and after repair, Little Goose Lock

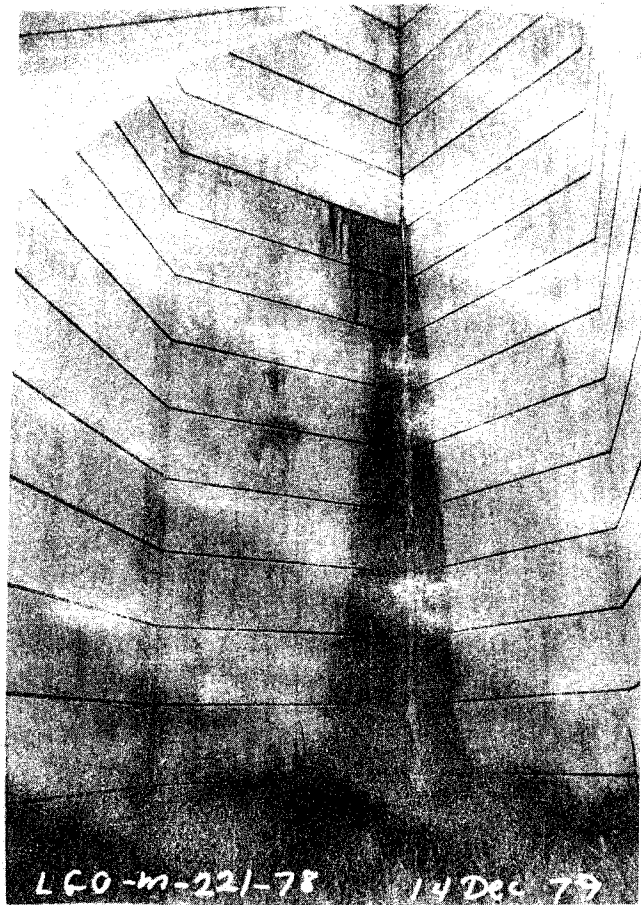
a. Monolith joint 13/15

153. Based on an inspection in August 1979, it was reported that several monolith joints exhibited small amounts of leakage (Figure 67) and would probably require regrouting in the future. It was suggested that one of the advantages of this repair system is that regrouting could be done easily and economically by an experienced chemical grouting crew. Other observations reported during this inspection included:

Figure 67. Monolith joint leakage, Little Goose Lock, December 1979

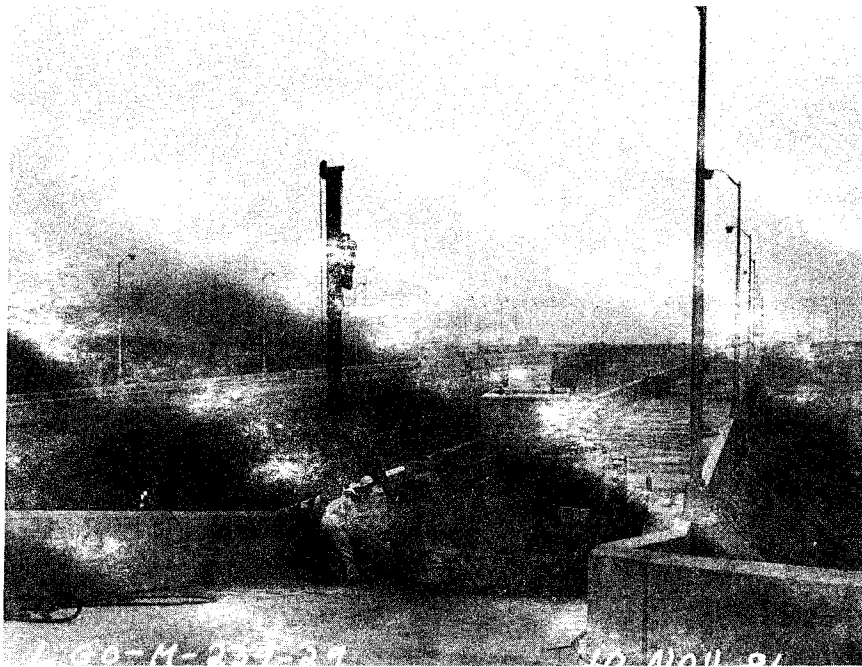
Figure 68. Track drill used to clean holes of grout from previous repair, Little Goose Lock

155. Holes to be regROUTED were flushed and cleaned using a combination of drilling and high pressure air/water blasting. This was accomplished using a Copco track drill (Figure 68) and a 6-in. roller bit. Two 6-in.-diameter stabilizers were added to the drill string as is done when drilling with a down-the-hole hammer. The stabilizers acted as reamers in cleaning the side-walls of the holes.

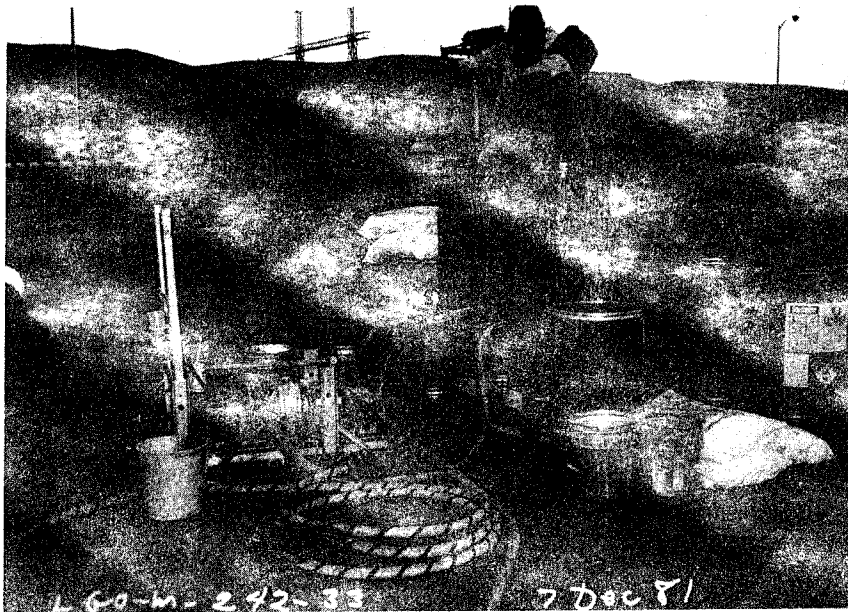
a. Mixing tanks and dual pump

Figure 69. Acrylamide grouting operations, Little Goose Lock

157. Drill holes along monolith joints 15/17, 22/24, and 24/26 were flushed and filled with approximately 300, 350, and 250 gal of acrylamide grout, respectively. Photographs of the grouting operation are shown in Figure 69. At one point, the grout line stuck in the monolith joint 24/26 hole

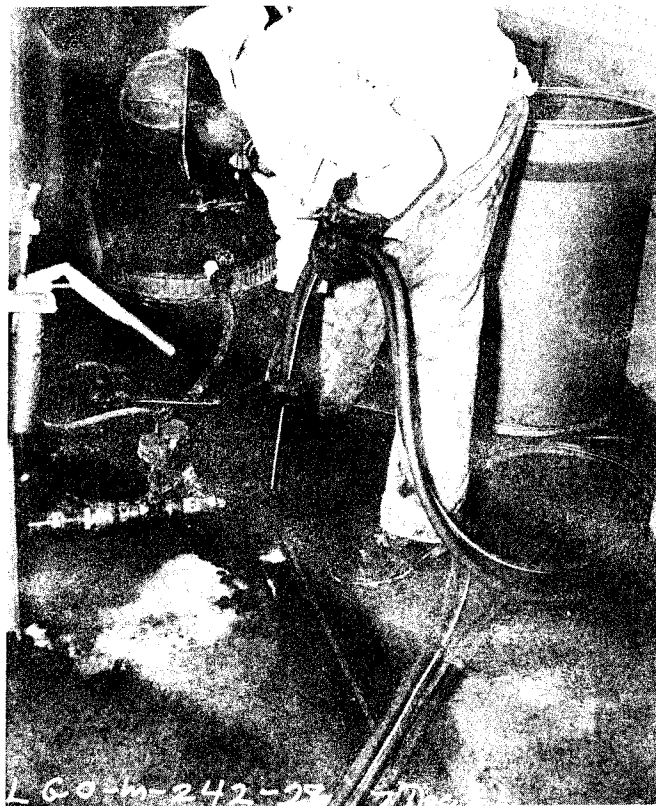
b. Individual grout hoses for each major grout component

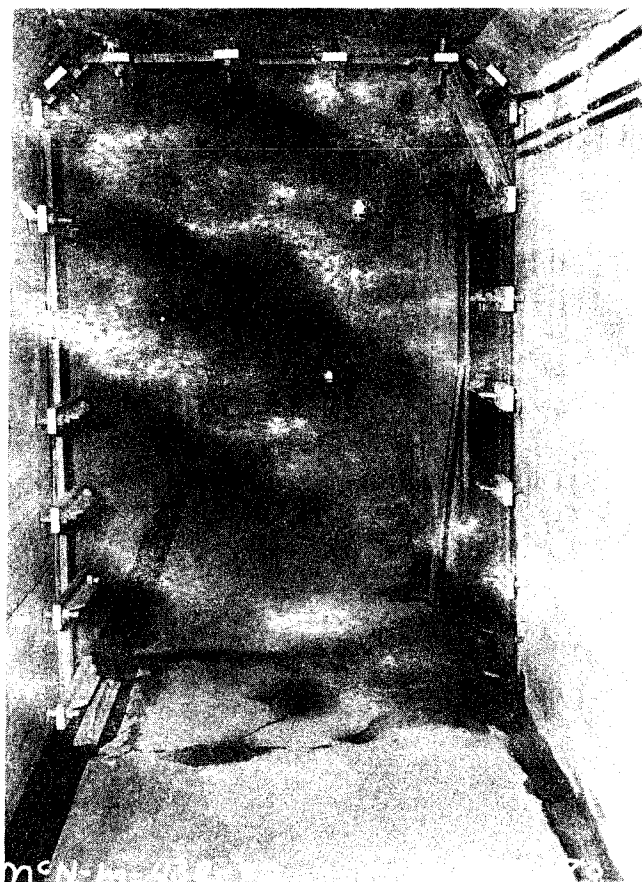
a. Joint 4/6 in the drainage gallery

Figure 74. Surface-type waterstops, McNary Lock, 1980

170. Leakage in the cross-over gallery at the construction joint between the lock's upstream sill block and the north overflow dam was again reported in October 1974. Progressive waterstop failures in the lock drainage and grouting galleries resulted in excessive leakage at the upstream sill. In 1973, leakage flooded the pump room damaging equipment to an extent that much of it required replacement. A surface-type gasket held in place by compressed steel bars bolted to the gallery walls (Figure 74) was used to control the leakage.

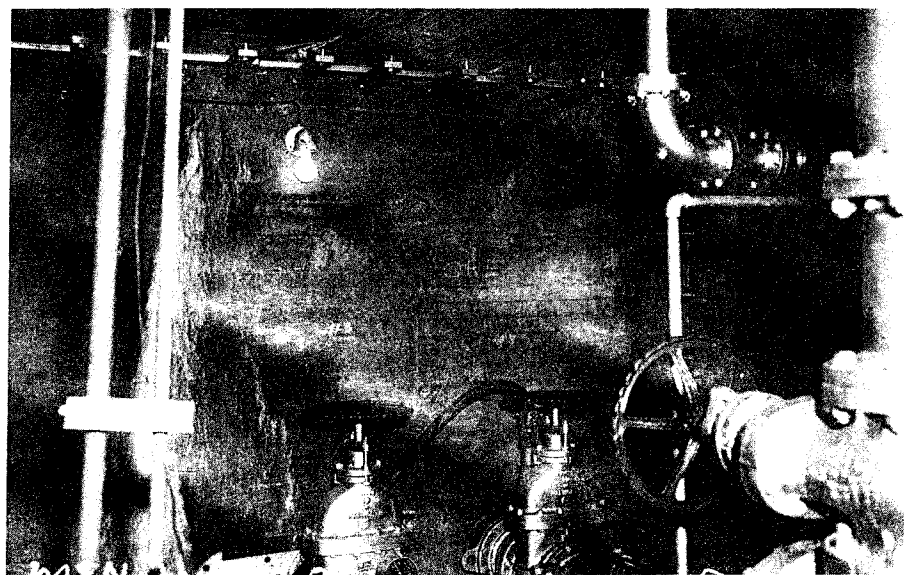
b. Joint 6/8 in the lower pump room

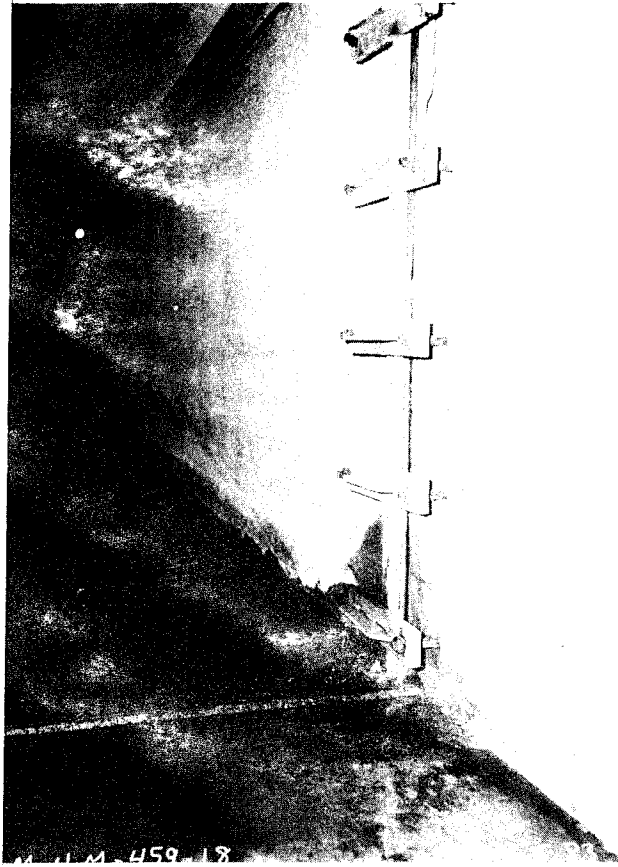
172. Joint leakage remained essentially unchanged at the next periodic inspection in 1983. A surface-type waterstop installed in the cross-over gallery at the joint between the downstream sill block and lock monolith 38 (Figure 75) continues to provide an adequate seal against leakage.

Figure 75. Surface-type waterstop, McNary Lock, 1983

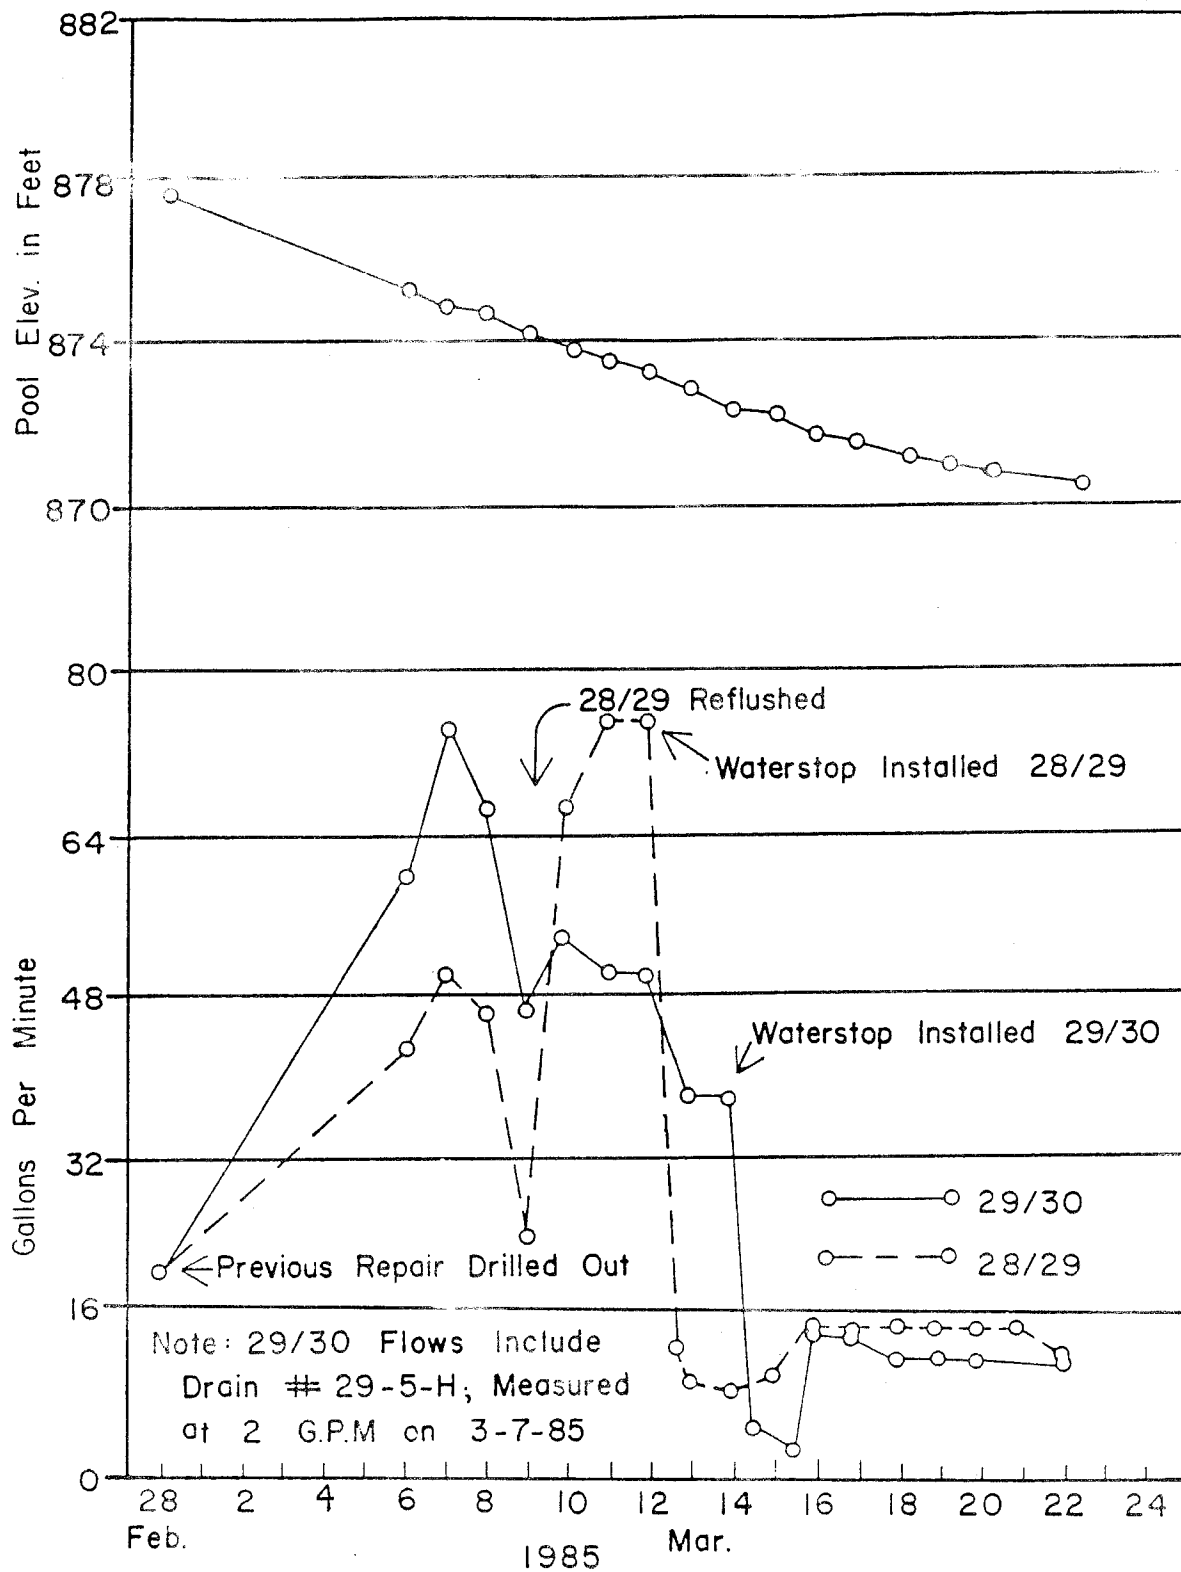
204. Historically, maximum flow through the three joints totals approximately 800 gal/min with a reservoir pool at elevation 950 ft. The reservoir pool level during the repair project ranged between elevation 880 and 870 ft (Figure 111) with a total flow of approximately 150 gal/min prior to repair. Of this total less than 1 gal/min was contributed by hole 30/31. Following installation of the remedial waterstops, total flow was stabilized at approximately 25 gal/min. As in most structures of this type, it is difficult to isolate leakage through monolith joints from that which is passing through horizontal lift joints. It is not known how much, if any, of the leakage into the drain was a result of openings in the lift joints. Results of this project indicate that the majority of flow has been through the vertical joints, yet it cannot be concluded that all of the flows are from the vertical joints.

206. Flow through joint 29/30 peaked at 75 gal/min on 7 March (Figure 111). On 8 March, the abandoned installation reached a depth of 145 ft (elevation 825 ft) before the tube was removed. The fluorescent dye test performed in May 1984 indicated a zone of leakage between elevations 870 and

Figure 111. Joint leakage rates, Pine Flat Dam

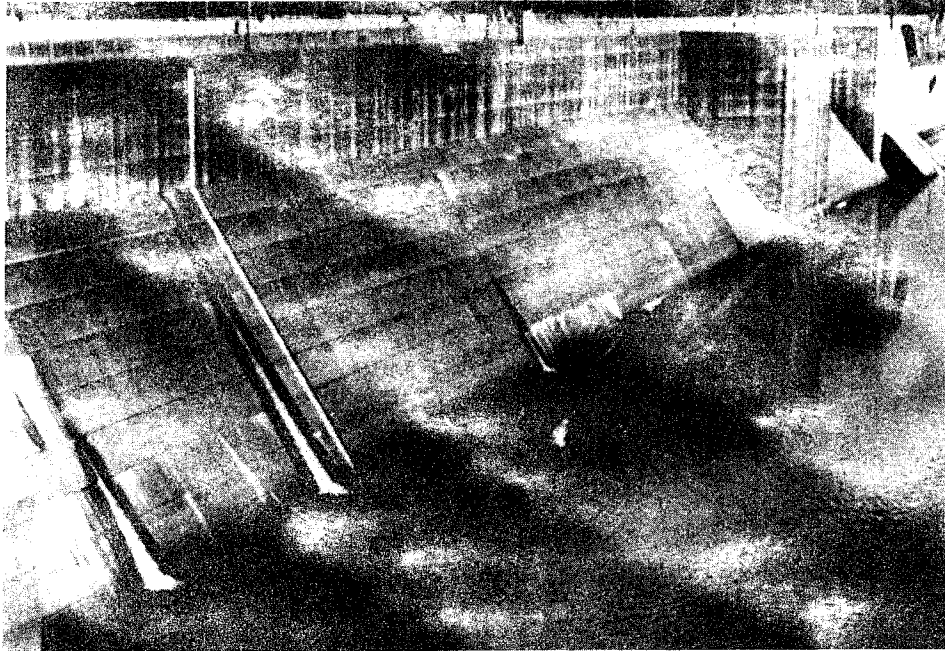
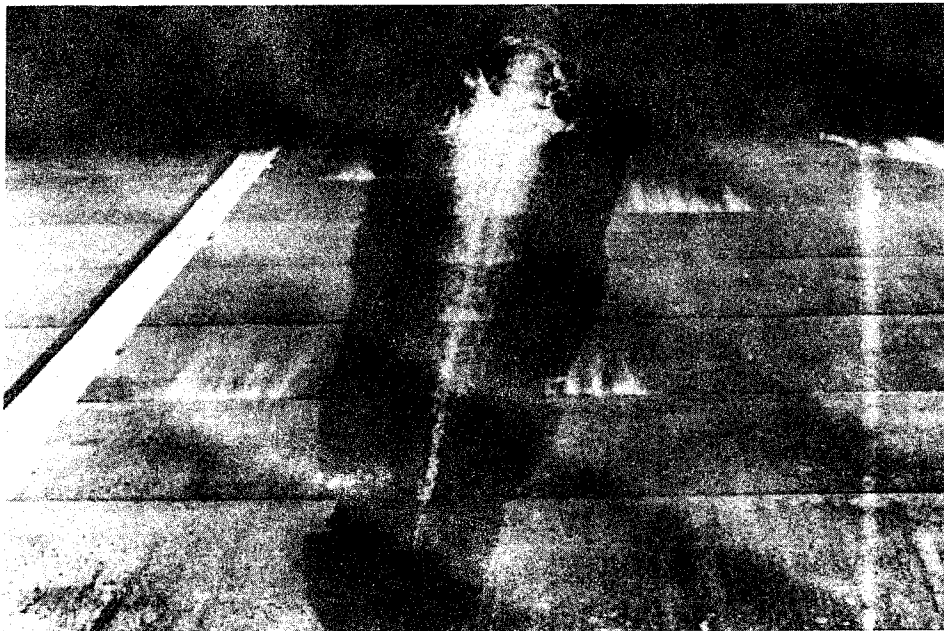
209. The Dardanelle Lock had six vertical monolith joints that had been leaking since 1975. The leakage only occurred during cold wintertime conditions. They were first investigated in January 1977 when the leakage had increased significantly (Figures 113 and 114). Observation and dye tests proved that water from the lock chamber, both at low and full chamber, was passing through the monolith joints. Defective copper waterstops were the probable cause of the leakage. Visual leakage existed at river wall monolith joints R7/8, R8/9, R10/11, R13/14, R18/19, and land wall joint L21/22. Monolith joints R18/19 and L21/22 are located at the lower miter sill and leakage through these joints entered the lock wall grouting galleries and then to the lower miter sill cross-over gallery where sump pumps are located. Total inflow during full lock chamber (wintertime) increased from 75 gal/min in January 1977 to 382.2 gal/min in January 1981. The sump pumps were taxed to the maximum and were modified several times to handle the high inflow.

a. View of riverward lockwall taken from dam looking downstream

b. Close-up of largest leakage

Figure 113. Leakage through monolith joints with lock chamber at upper pool level

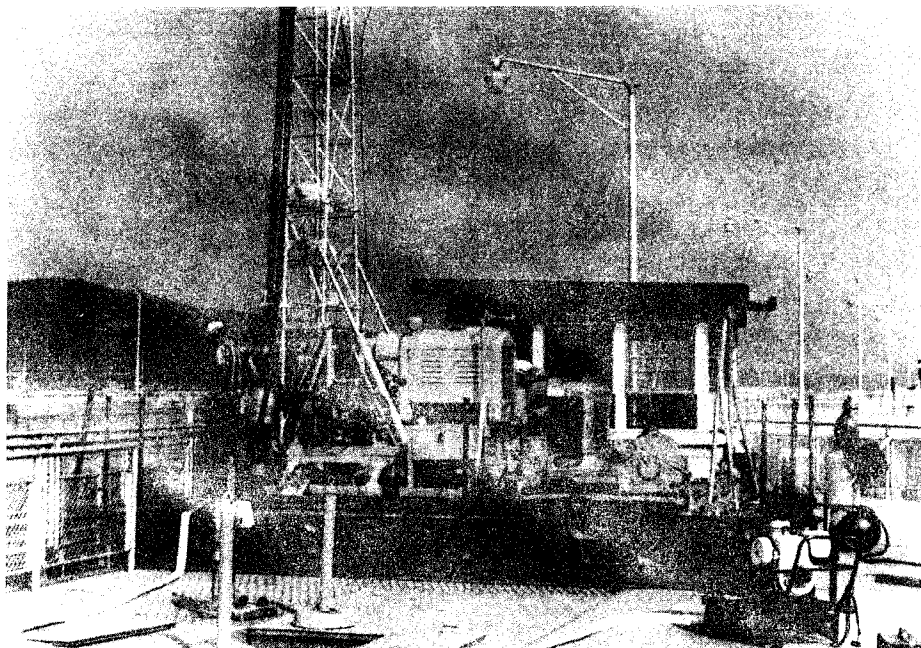
Figure 116. Drilling operations, monolith joint L21/22

b. Drill rig secured on location

the drill rig on location, a work platform was designed and built to enable a barge-mounted crane to do the task from the lock chamber (Figure 116). The drill was put in top working condition in order that accurate drilling alignment could be maintained.

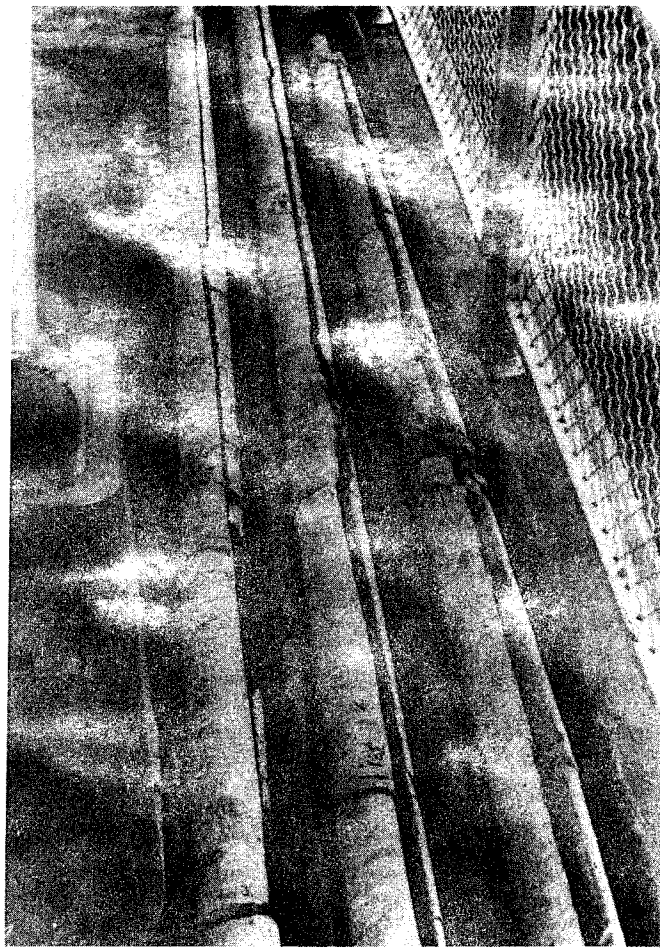
Figure 117. Concrete core from drill hole along monolith joint

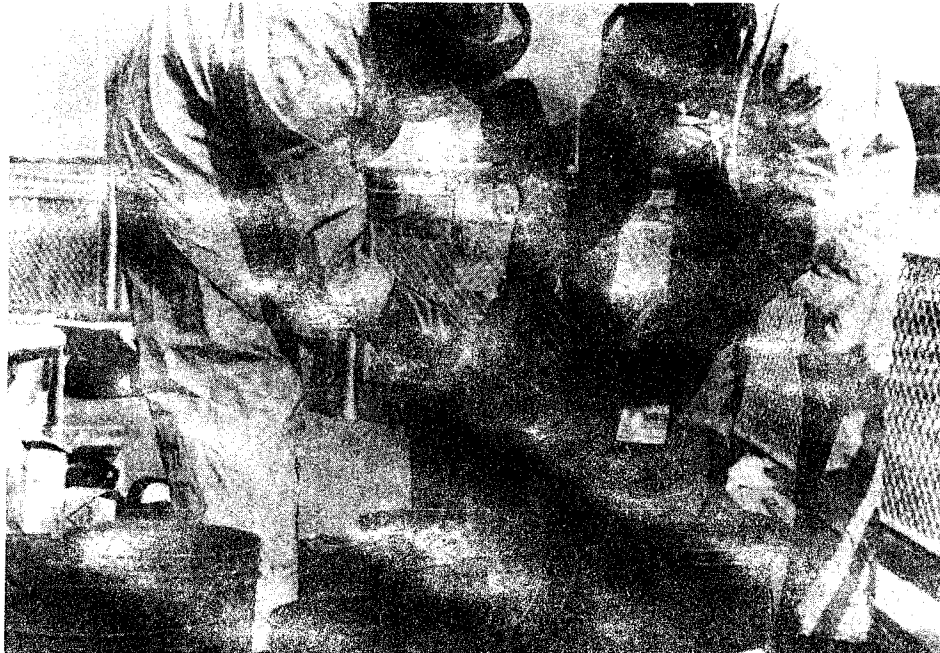
Figure 118. Mixing and placing operations

a. Saturating burlap bags with chemical grout

b. Saturated bag on top of drill hole awaiting insertion

217. The burlap bags and the CR-202 chemical were mixed together in large plastic garbage pails. Fifty bags were added to 5 gal of CR-202, one bag at a time, while being thoroughly agitated with a broom stick until fully saturated. The bags were then wrung by hand, leaving enough chemical in the bag to do the job expected (Figure 118). The saturated bags were stored in plastic garbage pails with lids.

218. The objective was to install the waterstop materials into the hole in a continuous operation. The hole was previously cleaned and contained water only. A driller and four helpers were needed during installation. Two men were on standby to relieve as needed. Bags were placed over the hole (Figure 118), one at a time, and a 20-ft N rod attached to drill line was allowed to free fall, taking each bag to the bottom of the hole. Tamping of the hole with the rod was done every seventh bag to remove voids. The driller had a marker on the drill line to indicate the bottom of the hole during "free falls" and the N rod was brightly painted to assist in visual safety. During short breaks the N rod was allowed to rest on bottom keeping the bags from floating upward, but not for over 2 min since the bags would have bonded to the rod. The bags were placed to within 2 ft of the top of the hole. Two dry burlap bags were placed on top of the saturated bags and weighted down until all curing had taken place. Later, the top of the hole was cleared of all CR-202 waste and capped with cement.

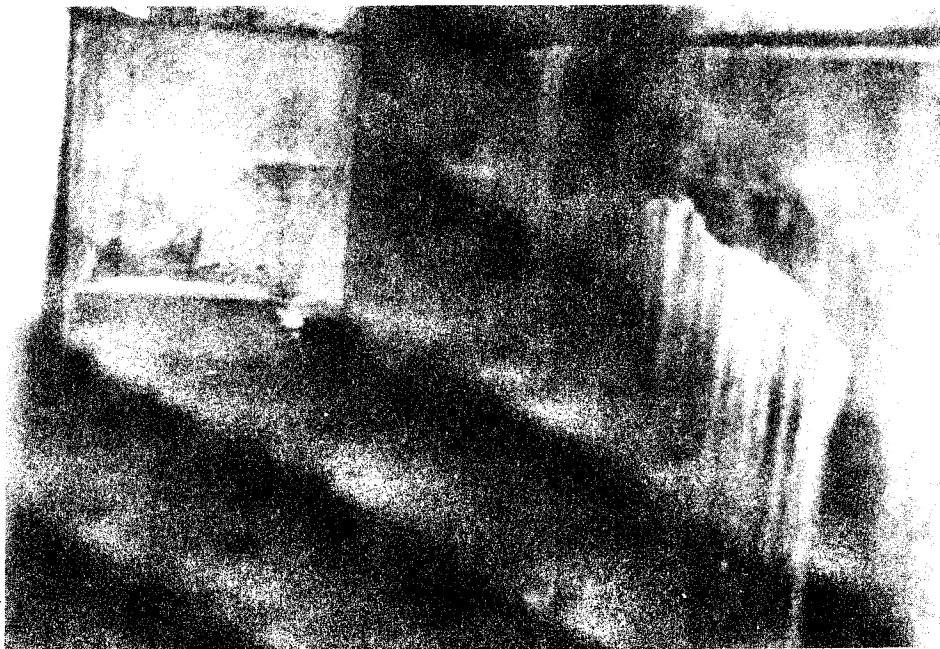
220. The new waterstops reduced the leakage into the galleries by at least 95 percent. Photographs of the leakage before and after waterstop installation are shown in Figures 114 and 119.

Figure 119. View of monolith joint R18/19 after installation of waterstop

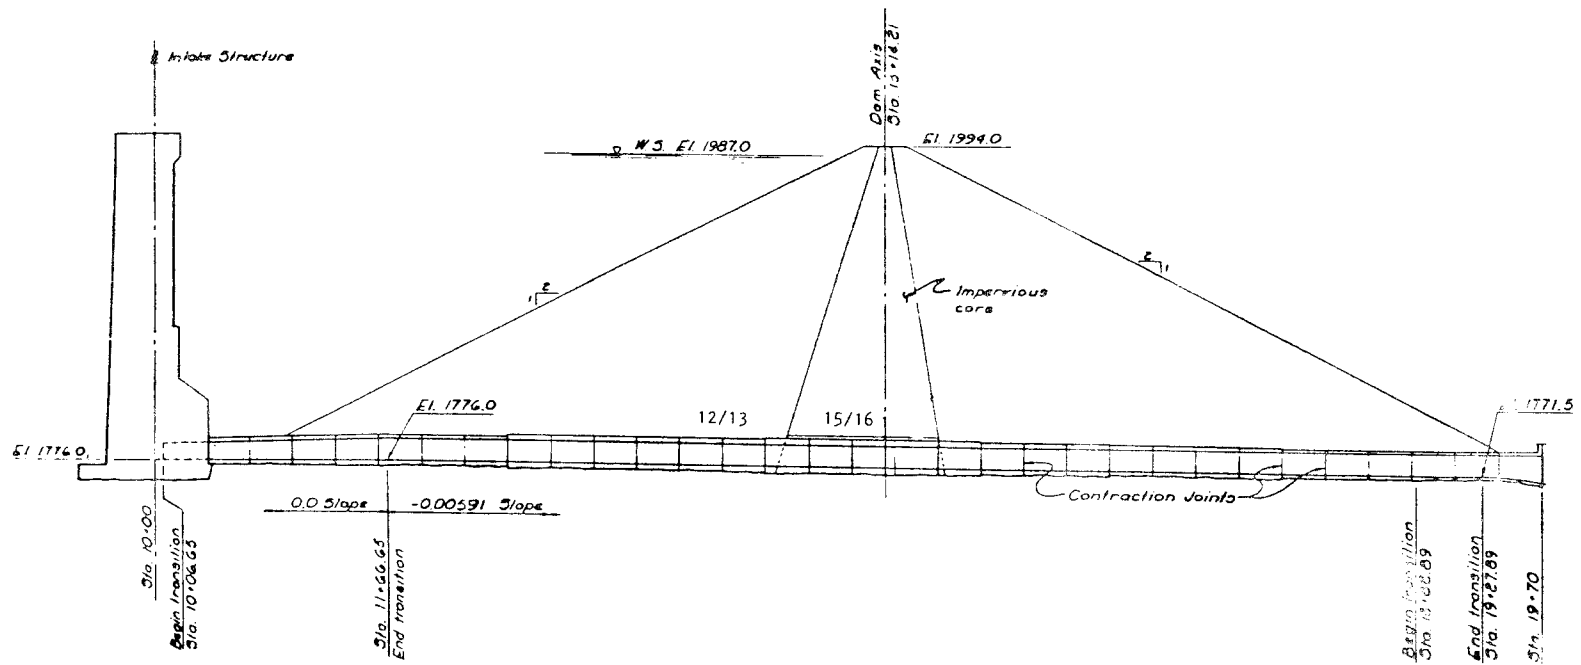
Figure 122. Regulating outlet conduit elevation, Applegate Dam

233. During the 20 May 1981 periodic inspection, significant leakage was observed through three joints in the regulating outlet conduit. Leakage at joint 15/16 was reportedly flowing at 3-5 gal/min from near the upper left side of the joint. Water was assumed to be flowing from the foundation rock along the joint to either a break in the waterstop or through a zone of porous concrete around the waterstop. Impervious core material is in direct contact with the conduit in this area (Figure 122). The potential for erosion of the core material was felt to be serious enough to warrant immediate repair. Leaks at the other two joints were located under the cobble and boulder zone and were not considered a threat to the integrity of the embankment. The District Hydrology Section recommended that repairs be made between 1 and 12 June. This time frame allowed for the best flow and temperature conditions when diverting water through the fish/water supply pipe.

234. Repair procedures called for core drilling two 1-1/2 in. holes near the bottom of the conduit with one hole on each side of the conduit. The characteristics of the water source were to be determined from these holes prior to grouting. Grout was to be pumped through the two drill holes into the contraction joint behind the waterstop and allowed to vent at the leak.

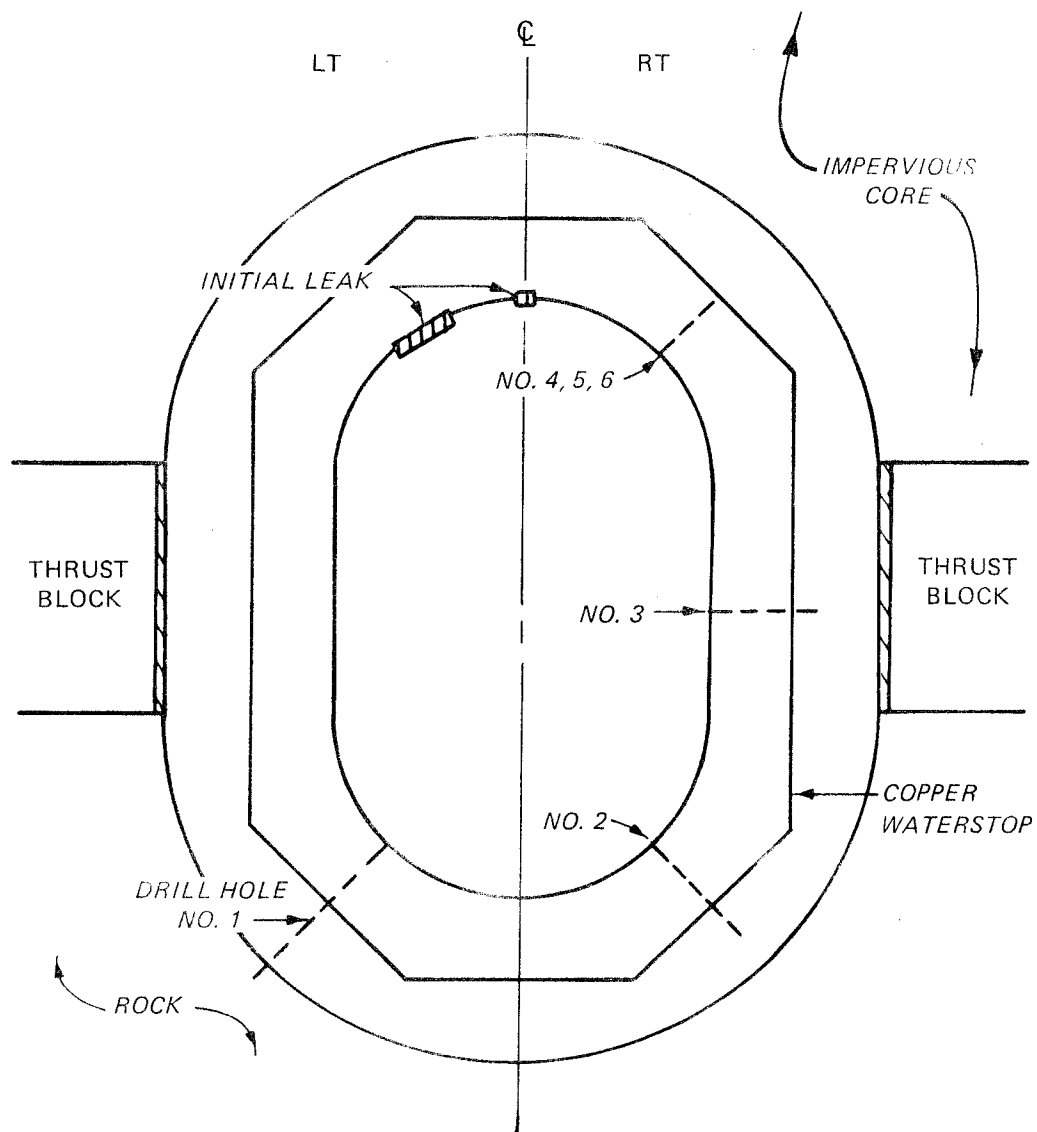
Figure 123. Grout hole locations, Applegate Dam

235. US Army Corps of Engineers crews began mobilizing on Monday, 1 June, and were ready to enter the conduit at the beginning of shift on 3 June. Two holes were drilled, as shown in Figure 123 and 124, and the conduit was made ready for the grouting contractor. Measured flow from the drill holes was 12.5 and 8 gal/min for holes 1 and 2, respectively. Flow through the leak with both drill holes flowing was estimated at 2.5 gal/min.

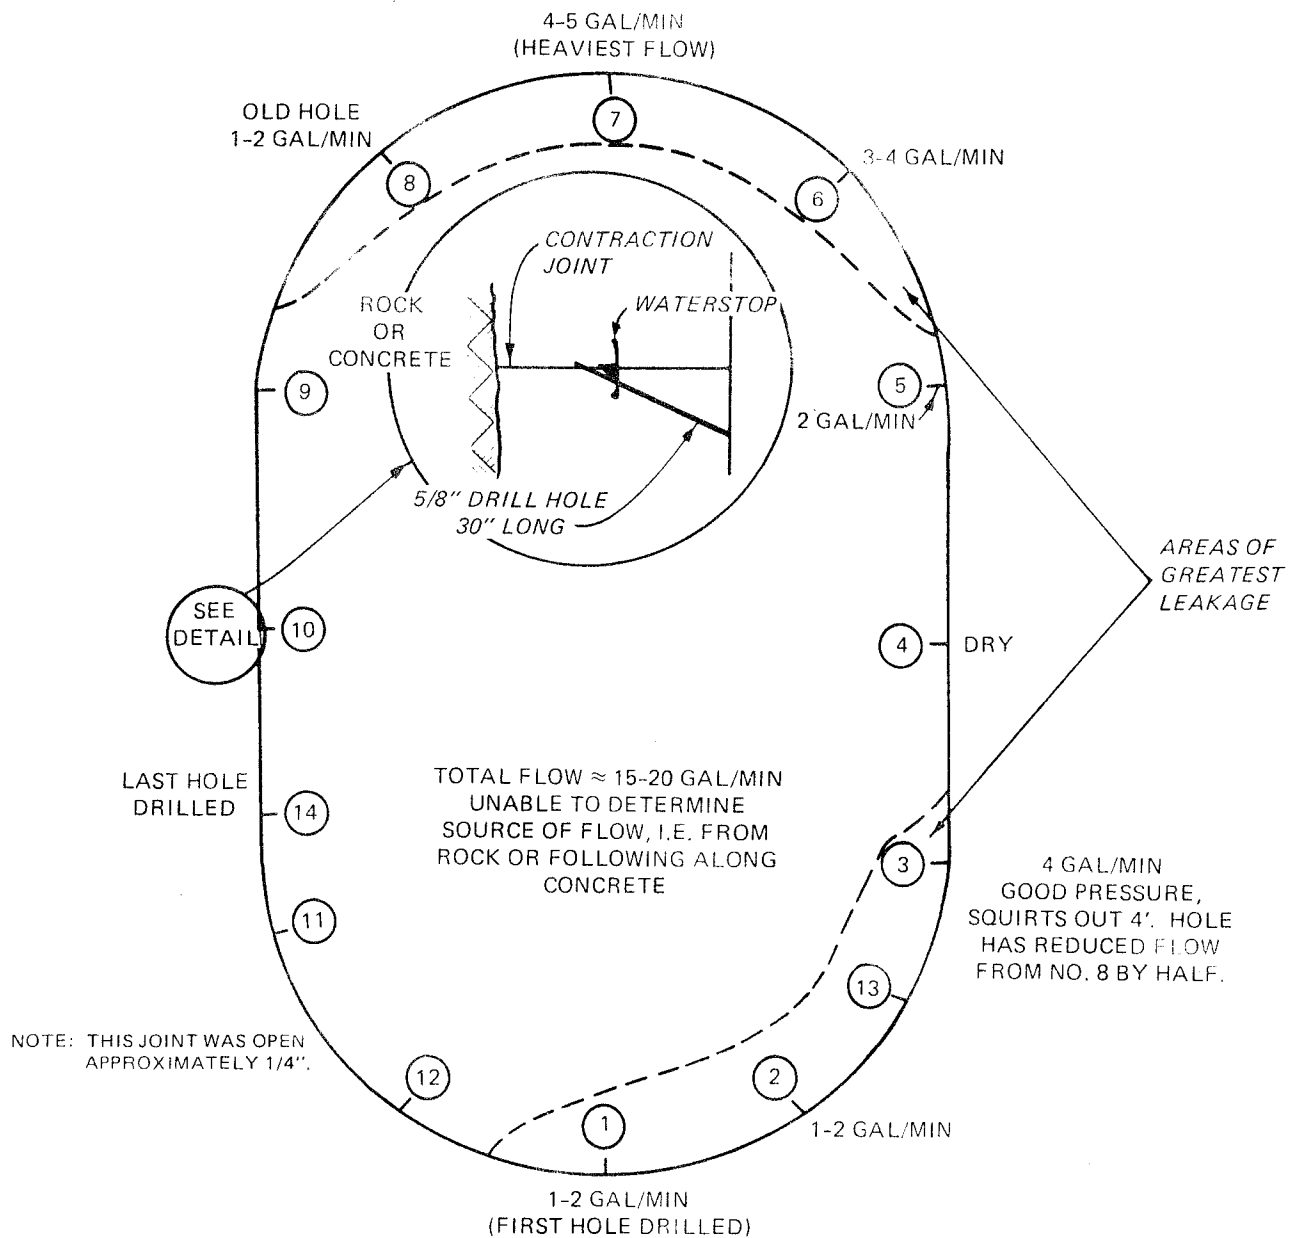
Figure 125. Section at joint 15/16 looking upstream, Applegate Dam

243. During the June 1984 periodic inspection, leaks were observed at several contraction joints, including joints 15/16 and 12/13. Although joint 15/16 had been repaired previously, concerns about possible erosion of the core were still valid. Leakage through the joint during the inspection was estimated at 1-2 gal/min at a spot about 8 ft up the right wall and 4-5 gal/min through a 1/2-in. drill hole (used in previous grouting efforts) located 18 in. upstream of the joint and halfway between the crown and spring line on the right side. US Army Engineer Division, North Pacific representatives at the inspection recommended that a repair be conducted within 60 days.

244. A contract was awarded to GELCO Grouting Service, Salem, Oregon, and repairs were begun on 25 July 1984. Fourteen holes were drilled around the perimeter of the conduit to intersect the contraction joint outside of the waterstop (Figure 125). The holes were 5/8-in. diameter and drilled with a Rotohammer drill. Flow through the holes varied from 0 to 5 gal/min, with a total flow of 15-20 gal/min. The system was open, because the contractor was unable to take pressure readings at any of the holes. Also, plugging one hole would cause an increase of flow at other holes.
